UNCLOS Continental Shelf Project – Arctic Ocean – Update #4

(March 8, 2009)

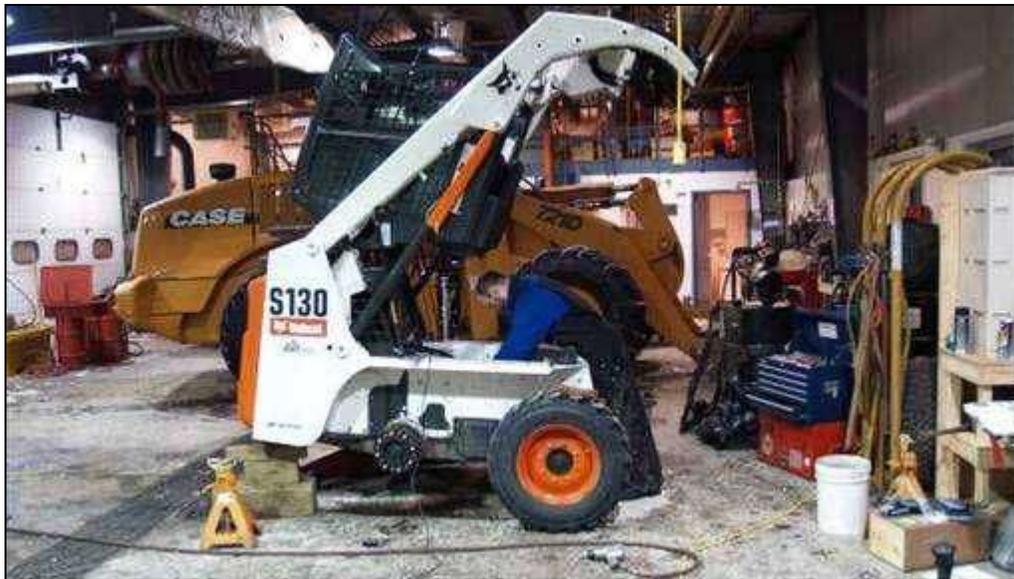
Bob – in the operating room

Changing out the control valve proved to be a huge undertaking and we were very fortunate to have the use of the Eureka garage to do the job in. After almost two days, the new the valve was in place, but there were still problems. Another day of back and forth on the phone with Stratford Farm Equipment and a bit of tweaking and testing seems to have gotten Bobbie back his strength. Now to get him out to the ice.

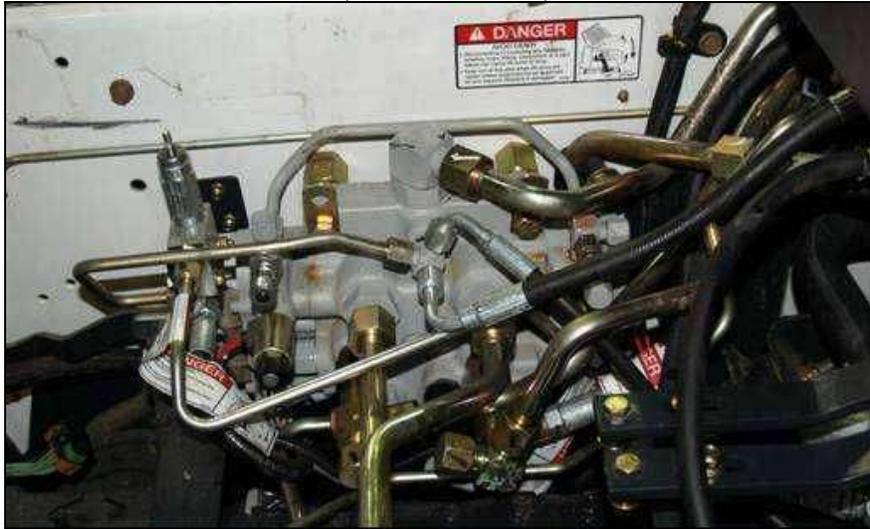
Bob's internal organs - Photo by Aaron Carpenter

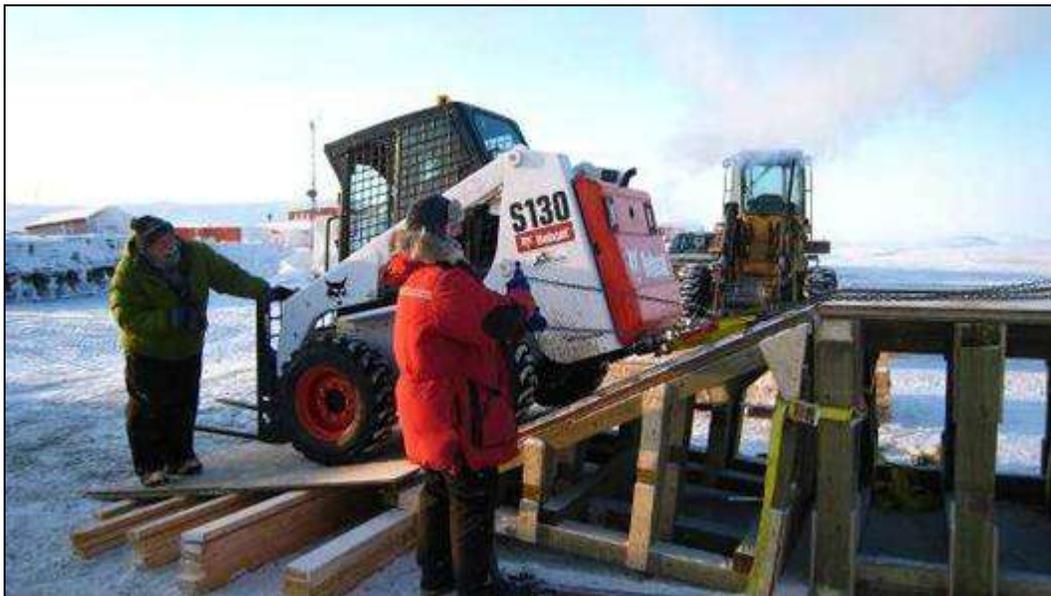
When the Borek ramp was assembled we discovered it came with an insanely steep incline and had to be modified to even get the wheels of the machine on to the slope without hitting the skid plate and frame. As a precaution, we put a chain falls from the back of the ramp down to the hitch on the Bobcat to take up strain and keep it from doing a face-plant down the ramp.
